TR21.01 Nonconformance Investigation, Root Cause Analysis, and Corrective Action

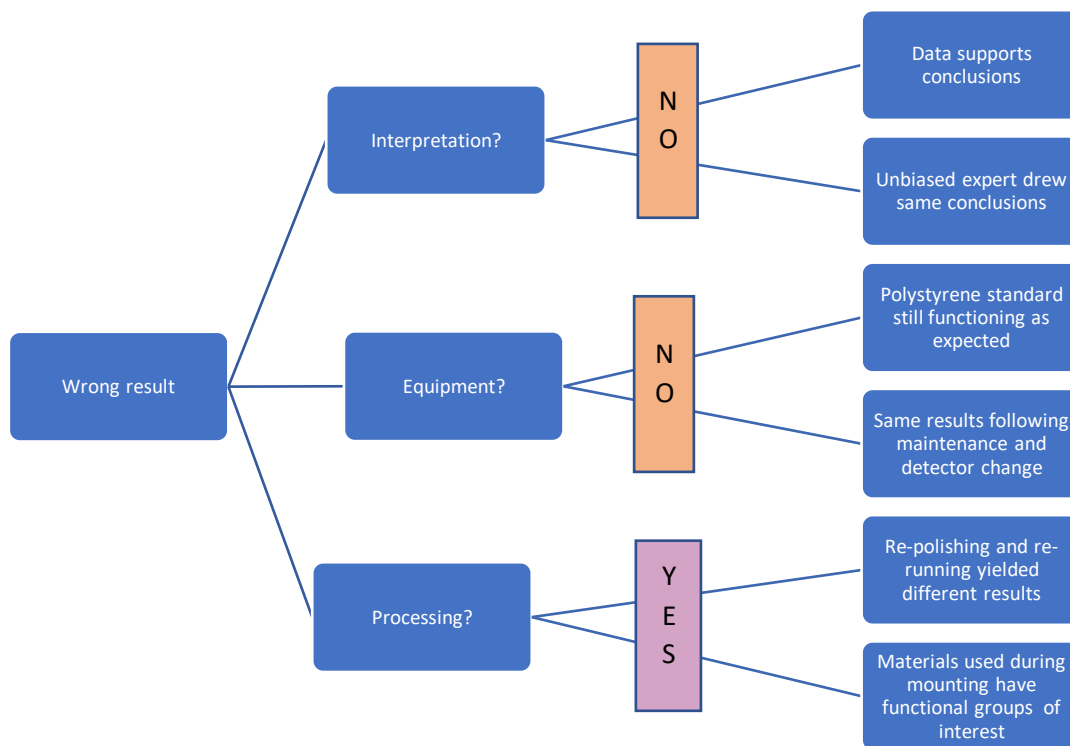
Sample preparation still remained to be the area possibly at fault. Dr. Suzuki and the analysts all saw differences in bandwidth and intensity near 1000 wavenumbers for Item 2. On a conference call with Dr. Suzuki on 8/18/21, there was a discussion about interfering substances resulting from the sample preparation procedure. An aluminum oxide component could show up in this region of the IR spectrum.

The analysts use a colloidal alumina suspension to polish the mounted samples. The analysts suspected some of this alumina was preferentially absorbing onto the surface of certain paint layers and getting detected during IR analysis.

When the analysts re-polished their samples, the artifacts previously showing up around the 1000 cm⁻¹ mark did not show up. One re-run showed the same artifact in a different layer.

The alumina suspension used during the final polishing step has the potential to leave a residue in certain paint layers, which gets picked up by the detector. Although a rare occurrence thus far, diligence during sample preparation is key. Both analysts, who rarely perform the paint sample preparation steps during casework, were rushing to finish their proficiency tests to meet the submission deadline (as evident by one analyst mislabeling one sub-item for another).

Either replace the alumina suspension with a diamond suspension to prevent residue from interfering with analysis, or insert a washing step to remove the alumina residue after the polishing step. Additionally, any suspected artifacts in future casework will trigger further sample preparation.

- Purchase a micro organic soap to apply after the polish to remove any micro-contaminants.
- Add washing step to SOP once detergent is tested and verified to work as intended.
- Re-prioritize proficiency test assignments, so deadline for completion is set earlier than manufacturer deadline for submission and analysts start earlier on assigned tests.
- Notify accreditation bodies of proficiency test outcome and investigative results.
- Notify customers of halted analysis while investigation is ongoing.
